Deterioration mechanisms of historic cement renders and concrete

Isobel Griffin. MA (Hons)

A thesis submitted to the University of Edinburgh
for the Degree of Doctor of Philosophy

July 2013

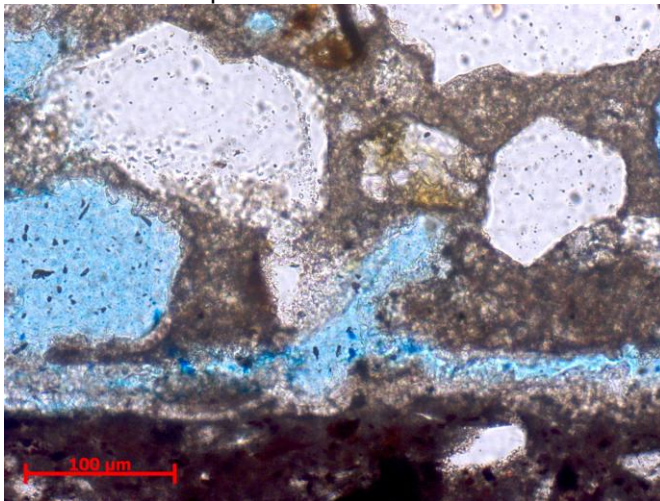
The brick surface appeared smooth and non-porous, suggesting it would have been difficult to bond to, and there were almost continuous voids along the render-brick interface, joined together by cracks. These voids were again filled with portlandite and calcite (Figs. 9.17 and 9.18). Cracks in the bricks adjacent to the render-brick interface suggested that water had penetrated through to the bricks and promoted their deterioration (Fig. 9.19).

Fig. 9.17. Voids filled with portlandite and calcite crystals along the interface between B25 RR and the brick (render in upper part of image, brick in lower part), plane polarized light, field of view: 440 μm across

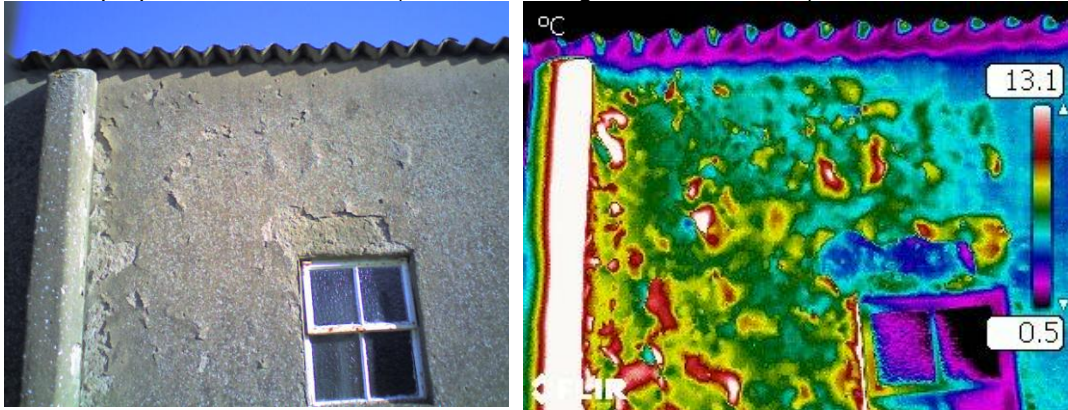
Flaking was observed on approximately one third of the cement-rendered airfield buildings, and was more prevalent on the south elevations and adjacent to the raised piers. Infrared thermography undertaken on a cold but sunny day showed that the surface of the flaking render was warmer than the surrounding render because the cracks below the surface had created a surface skin (Fig. 10.3). It also suggested that the extent of the deterioration was greater than was visually apparent, because some of the warmer areas appeared in good condition but were found by tapping to be hollow, suggesting they were beginning to deteriorate.

Fig. 10.3. Infrared thermography on Building 46 showing that the surface of the flaking render was warmer than the surrounding render. The infrared thermograph is a false colour image showing the surface temperature of surfaces in °C, where the red areas are warmest and the purple areas are coolest (Maureen Young, Historic Scotland)

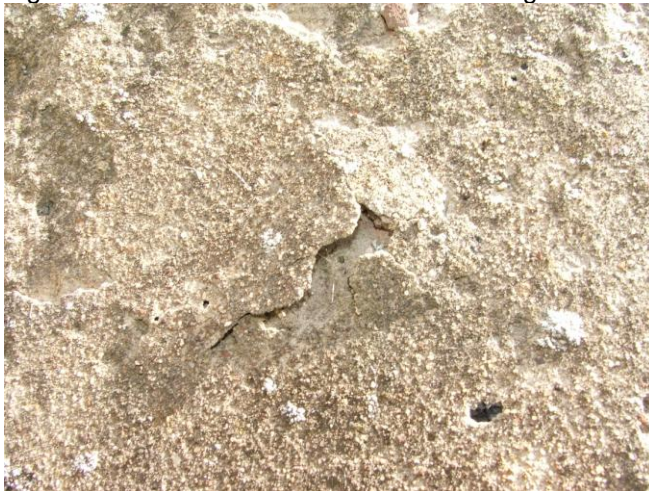
In its early stages the deterioration appeared as small, raised blisters, sometimes with layered aggregate particles visible below the cement-rich surface (Figs. 10.4-10.5), and as it progressed the blisters joined together, causing substantial areas of the render surface to distort and detach. In some places the surface skin had been lost altogether, exposing friable plaster underneath with small holes left by aggregate particles and some exposed aggregates, including flaky grey and yellow

Fig. 10.4. Raised blister of render on Building 46

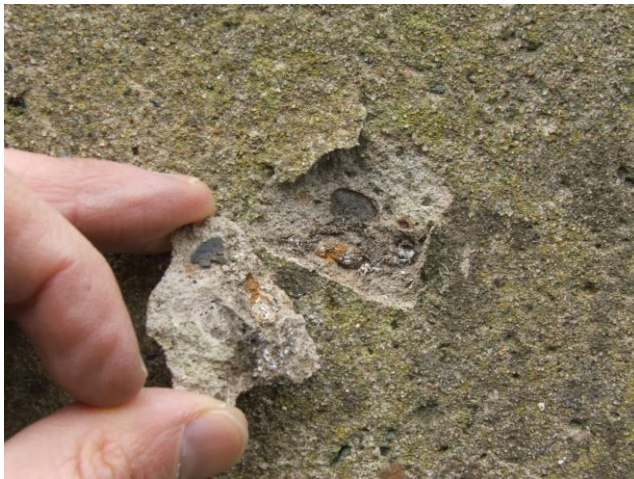
particles. When the blisters of render were removed they were typically cone shaped, with a flaky grey or yellow particle at the base of the cone (Fig. 10.6). It was observed that after rain the areas of detaching render appeared much wetter than the surrounding render, and speculated that this might be because the aggregate particles just below the surface absorbed water (Fig. 10.7).

Fig. 10.6. Detached blister of render on Building 25, with fractured grey aggregate particles visible inside

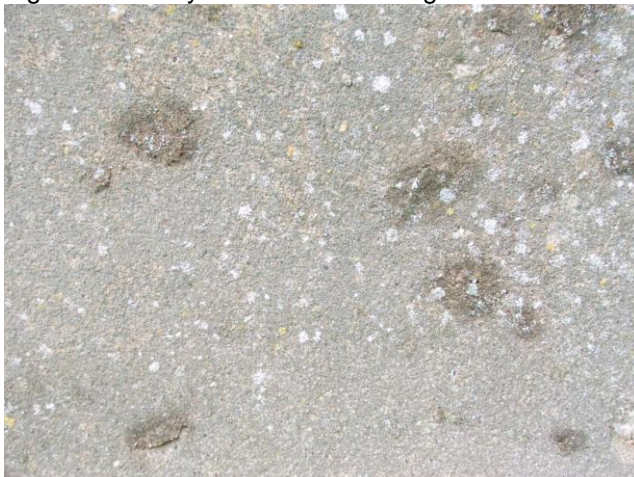
Fig. 10.7. Visibly wet areas of flaking render on Building 47, following rain

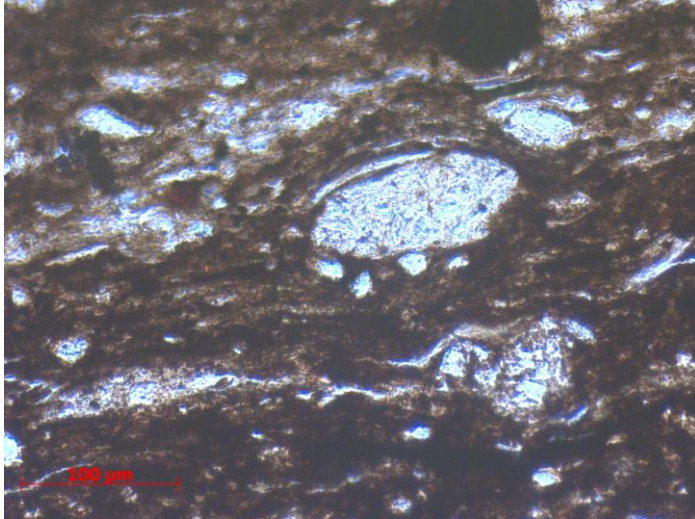
Thin section examination of the aggregate particles from Building 47 that were thought to be related to the flaking showed that they were similar to the mudstone identified in the Building 47 render. They all had layered structures and a significant silt or clay content, and some were rich in quartz (Figs. 10.8-10.10). They were therefore classified as shale, which is defined as a 'fissile and laminated' type of mudstone [224]. The particle analysed using SEM-EDX consisted of layers of quartz-rich material, with tiny particles of iron-rich material between the layers, which were probably clays (Fig. 10.11). XRD analysis of the clays extracted from the aggregates indicated the presence of kaolinite, with traces of illite, smectite and chlorite. Smectite is a swelling clay and chlorite can weather to form swelling layers of smectite interspersed with non-swelling layers [149], although it is doubtful whether the clay concentrations were sufficient to cause significant swelling.

Fig. 10.8. Aggregate particle from B47 OR thought to be related to the flaking: mudstone with aligned, compacted carbonate clasts, plane polarized light, field of view: 440 μm across

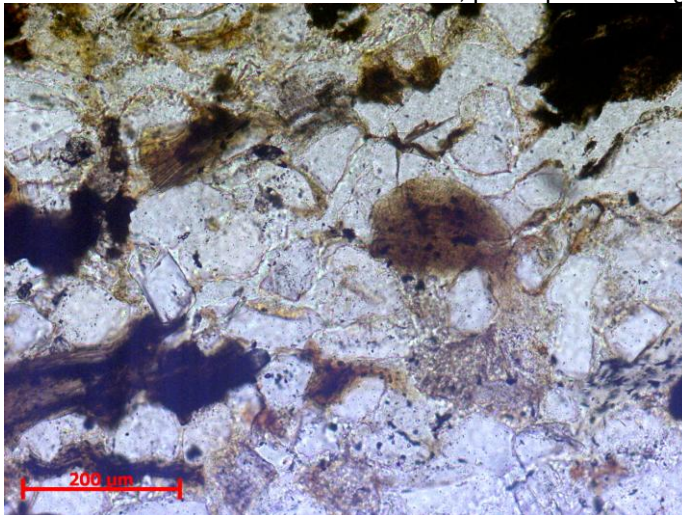
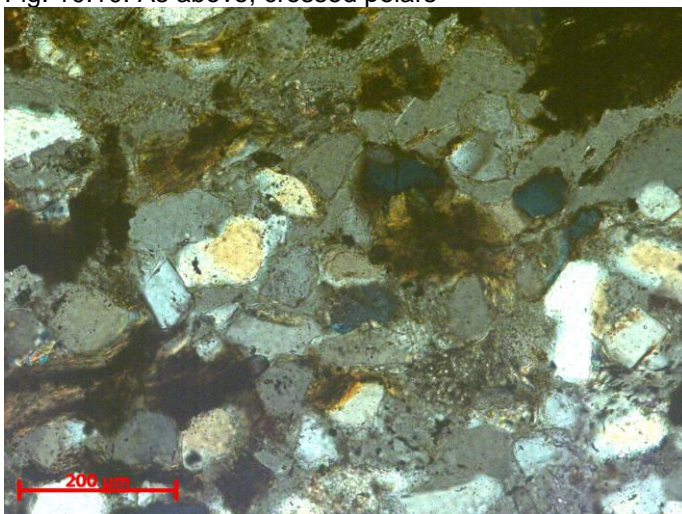
Fig. 10.9. Aggregate particle from B47 OR thought to be related to the flaking: well-cemented sandstone clast with a mud-rich matrix, plane polarized light, field of view: 875 μm across

Fig. 10.10. As above, crossed polars

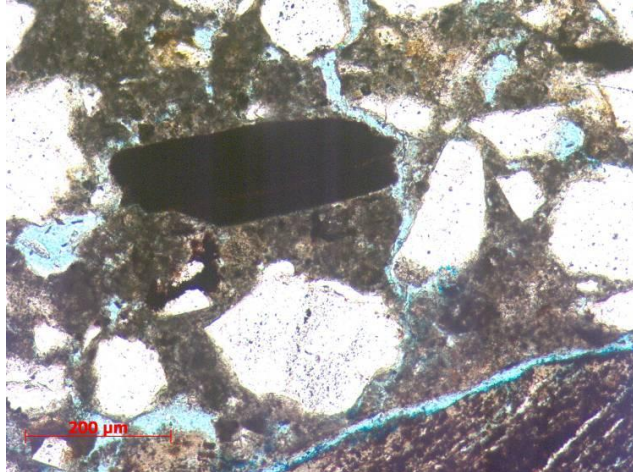
Both the thin sections and the SEM micrographs showed cracks in the render emanating from the layered aggregate particles, suggesting that the particles might be causing the macroscopic cracking and flaking observed (Fig. 10.12).

Fig. 10.12. Crack going from the mudstone aggregate particle in the Building 25 blister to the render surface, plane polarized light, field of view: 875 μm across

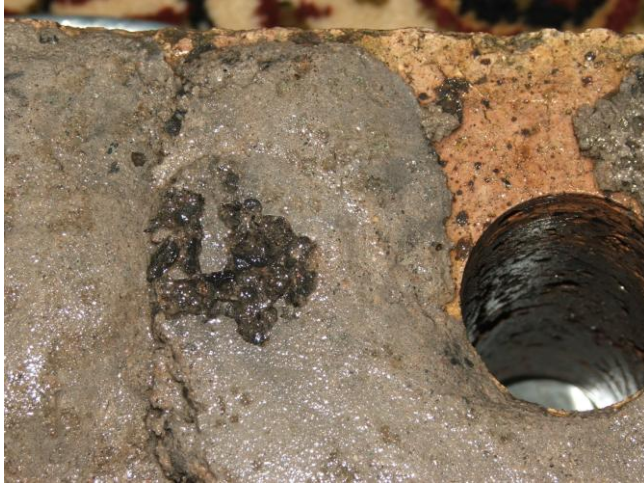
However, surface pitting of the LS render was observed after only four freeze-thaw cycles, and had worsened by the end of the experiment (Fig. 10.16). No deterioration was observed in the HS render due to freeze-thaw, possibly because the mixing process had broken down the shale particles to below the size needed to cause surface cracking.

Fig. 10.16. Surface pitting of the LS render after 14 freeze–thaw cycles

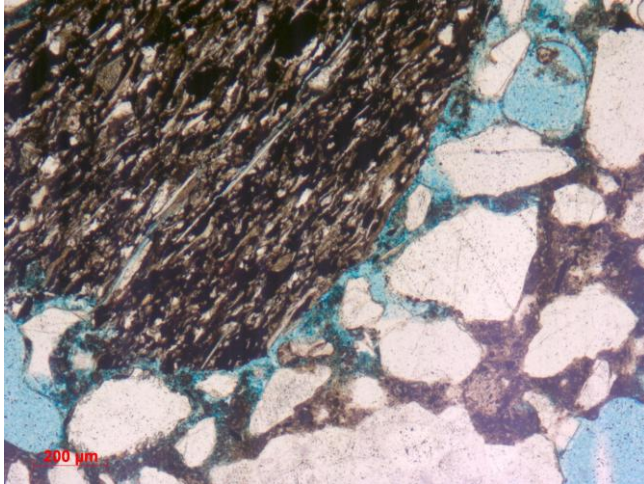
Petrographic examination showed there were cracks inside the shale particles and running along their edges even before weathering, presumably because the particles absorbed water when the mix was wet and shrank as they dried out (Fig. 10.17). Areas of high microporosity and larger pores tended to occur along the interfacial zone, and this would have created regions of reduced modulus and tensile strength, where fracture initiation was likely to occur [210]. The shale particles were notably more disaggregated in the samples which had undergone wetting cycles, and there was some microcracking of the cement paste. Further microcracking was evident after freeze-thaw cycling, with the cracks generally beginning at the aggregate and propagating through the cement in a direction perpendicular to the aggregate surface. The thin section examination of the LS render where surface pitting occurred showed that the surface had largely disintegrated and the pressure generated had been sufficient to crack some quartz particles (Fig. 10.18).

Fig. 10.17. Area of high porosity around a shale particle (upper left) in the HS render before weathering, plane polarized light, width of image 1750 μm

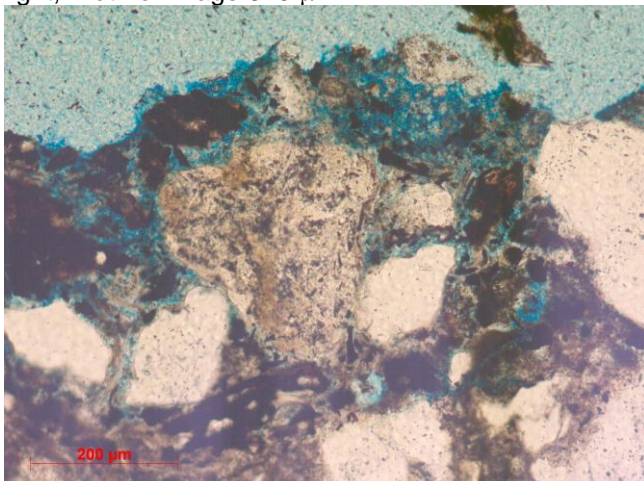
Fig. 10.18. Surface disintegration of the LS render after freeze-thaw cycling, plane polarized light, width of image 875 μm

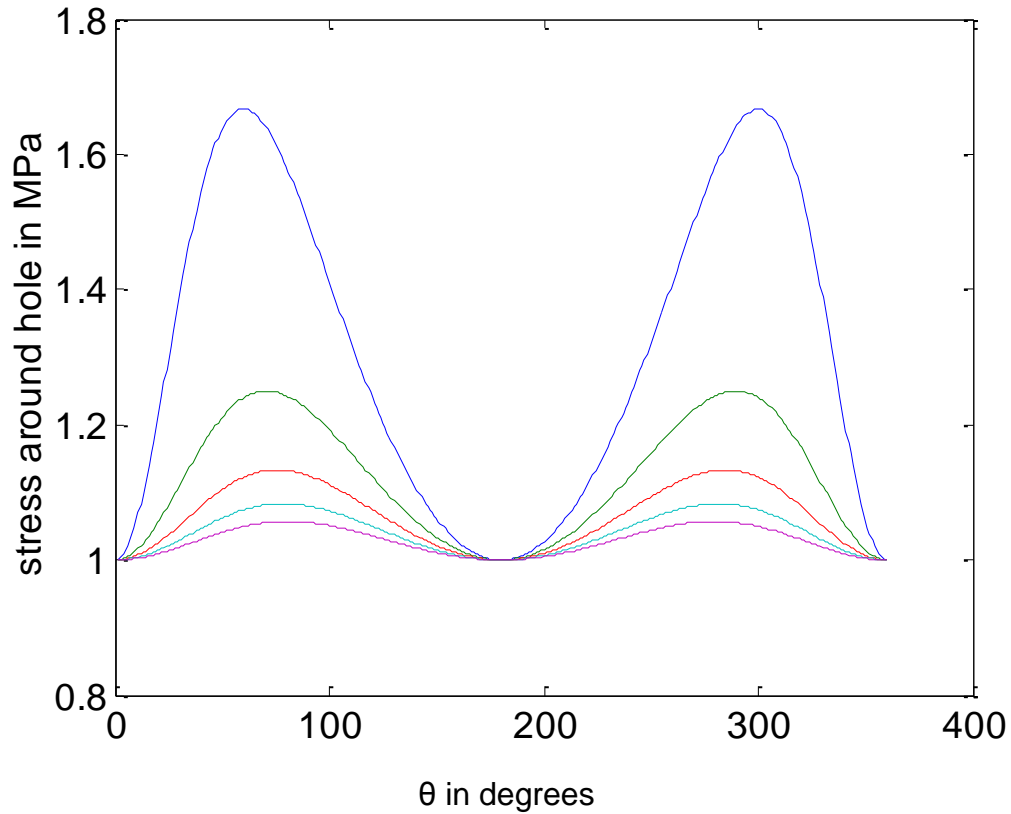
The variation of HS for different values of d and θ is shown in Fig. 10.22. This demonstrates that fracture will initiate at well defined angles, which move according to the render thickness, and that the stress on the hole is up to 1.66 times greater than the isotropic applied stress inside it. The θ values corresponding to the maximum tensile hoop stress on the edge of the hole are 60° and 300° for $d = 2$ mm,

moving to 80° and 280° as d approaches 6 mm. This means that the angle of the pop out increases from 120° to 160° as the render covering gets thicker, which explains the observed conical shape of the pop outs.

Fig. 10.22. Stress distribution around the hole, with each plot corresponding to a different value of d . Blue is $d = 2$ mm, green is $d = 3$ mm, red is $d = 4$ mm, cyan is $d = 5$ mm and purple is $d = 6$ mm; $r = 1$ mm.

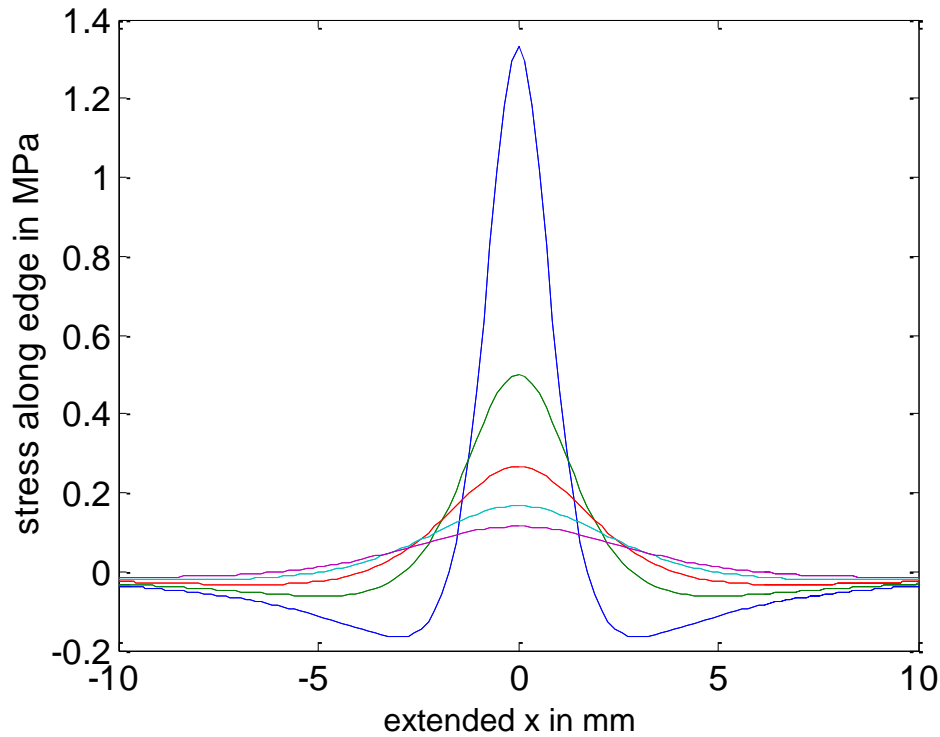
The stress on the straight edge is both tensile and compressive, as shown in Fig. 10.23. The point of maximum tension is at $x = 0$ mm, directly perpendicular to the shale particle. However, when r is 1 mm the stress around the hole is always greater than the stress along the edge, indicating that fracture will initiate from the hole rather than at the point of maximum tension. The likelihood of warping or buckling increases with decreasing d , therefore thin render layers are most vulnerable to warping and damage.

Fig. 10.23. The stress along the edge, showing compressive stress (negative values) and tensile stress (positive values). As before, blue is $d = 2$ mm, green is $d = 3$ mm, red is $d = 4$ mm, cyan is $d = 5$ mm and purple is $d = 6$ mm; $r = 1$ mm.

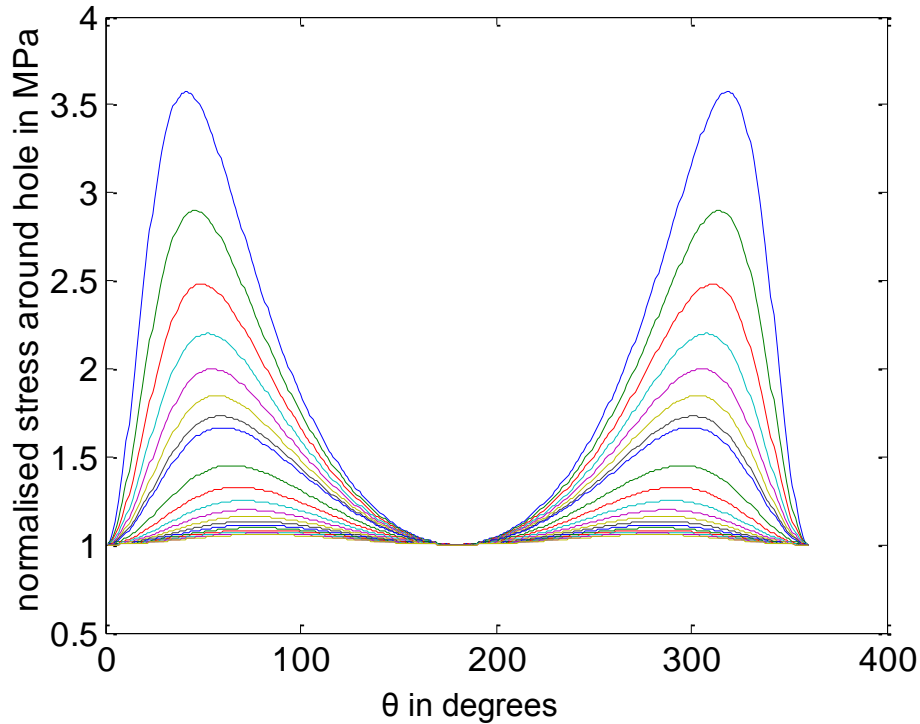
Increasing the size of the cavity while maintaining the same applied pressure will generate greater pressure on the cavity wall and change the angle of the conical pop out. Normalising all lengths in the calculation by dividing d by r , where r varies from 1 to 3 mm, shows the minimum and maximum stresses experienced with these defined parameters of r , d and P (Fig. 10.24). The highest stresses on the cavity wall are produced by the lowest values of d/r , ranging from $4/3$ to 6. The angle of maximum stress varies from around 41° to 69° , and correspondingly also from $(360 - 69)^\circ$ and $(360 - 41)^\circ$, with the shallowest angles resulting from the lowest values of d/r and the highest stress on the cavity wall. The maximum tensile stress along the straight edge exceeds the stress around the hole for $d/r = 1.33 - 1.73$. This means that for large cavities with a thin covering of render, the crack initiates on the render surface rather than at the cavity.

Fig. 10.24. The stress on the cavity wall calculated using d/r and plotted against θ . The highest stresses result from the lowest values of d/r , as shown in the uppermost blue curve, where the stress is approximately 3.5 times the applied pressure

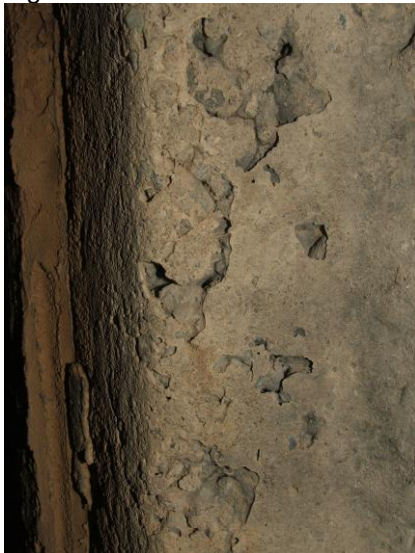
Fig. 11.7 Voids visible at the surface of the concrete

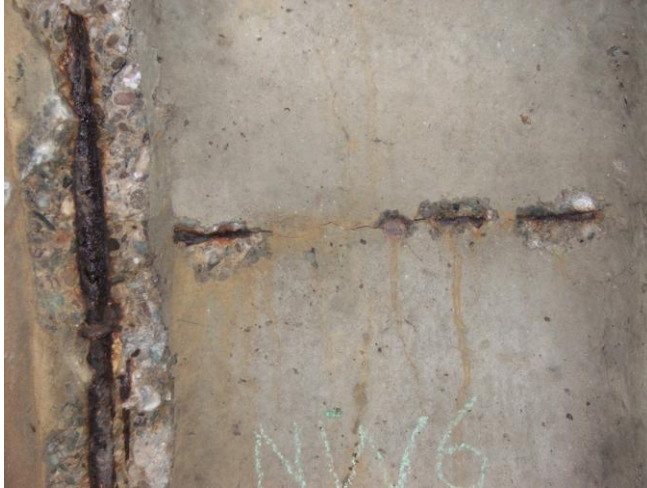
The most common type of deterioration was the corrosion of the rebars, which had generated significant expansive forces causing the concrete to crack and delaminate. As the horizontal rebars were close to the surface, they were often exposed with the loss of only a few millimetres of concrete. However, the corrosion had led to more substantial losses of concrete on the ribs where the bars were buried deeper (Fig. 11.8). The losses on the ribs were particularly severe at either end of the air raid shelter.

Fig. 11.8. The cracking and delamination of the concrete due to corrosion of the rebars

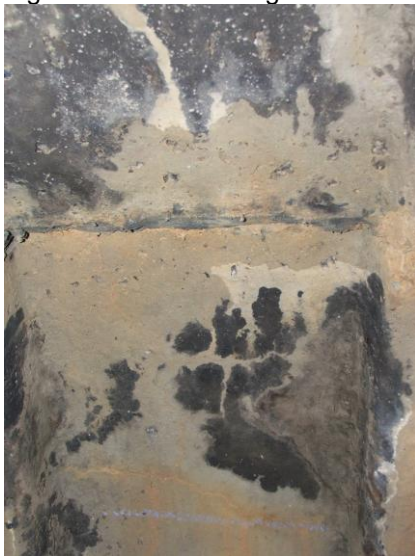
surface of the concrete (Fig. 11.9), which was probably biological growth. Fluffy salt efflorescences were also sometimes present, mainly at the base of the walls (Fig. 11.10).

Fig. 11.9 Black staining on the surface of the concrete

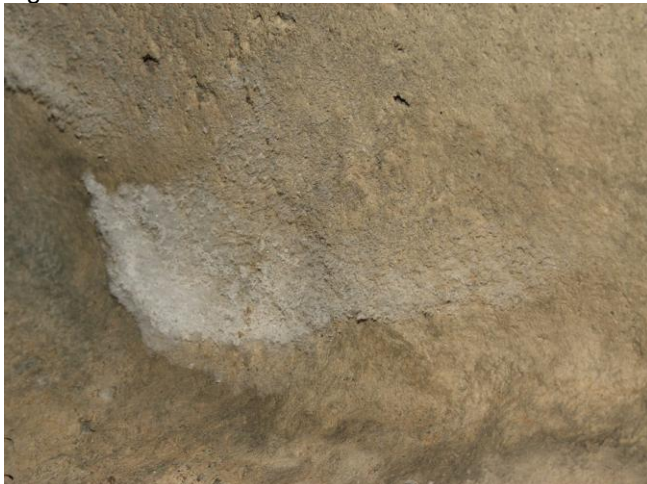
Fig. 11.10 Salt efflorescences on the surface of the concrete

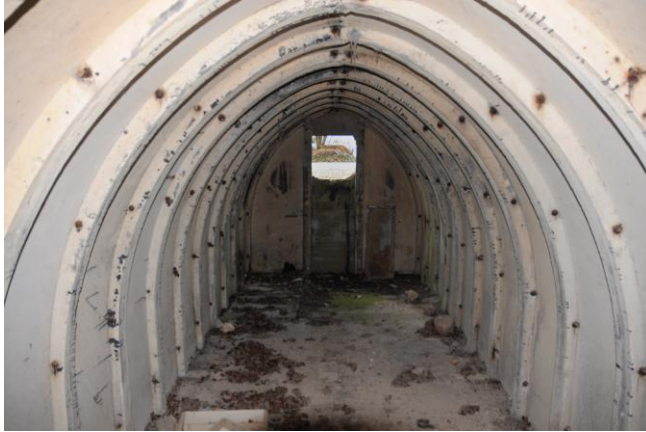
The problems experienced by the shelter at NMOF were clearly not unique, because the Stanton shelter at Cark airfield in Cumbria was observed to be in similar condition. From photographs some other Stanton shelters appeared to be in much better condition inside, and although this may have been because they had been extensively repaired, the shelters in good condition also had the sections bolted together throughout rather than joined with mortar. The bolting may be beneficial in reducing moisture ingress (Fig. 11.11).

Fig. 11.11 The interior of the Stanton shelter at RAF Chilbolton, Hampshire, showing how the concrete sections have been bolted together along the ribs (Richard Hall).

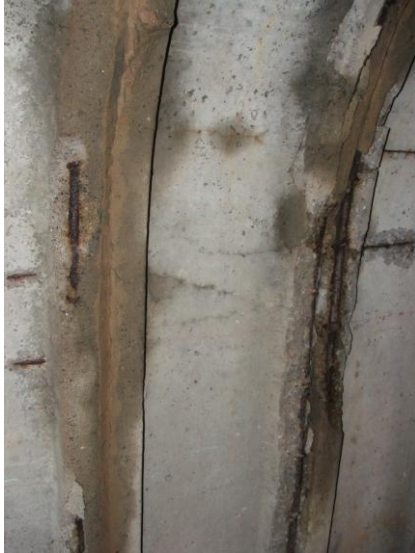
Fig. 11.12. Localised damp patches after rain

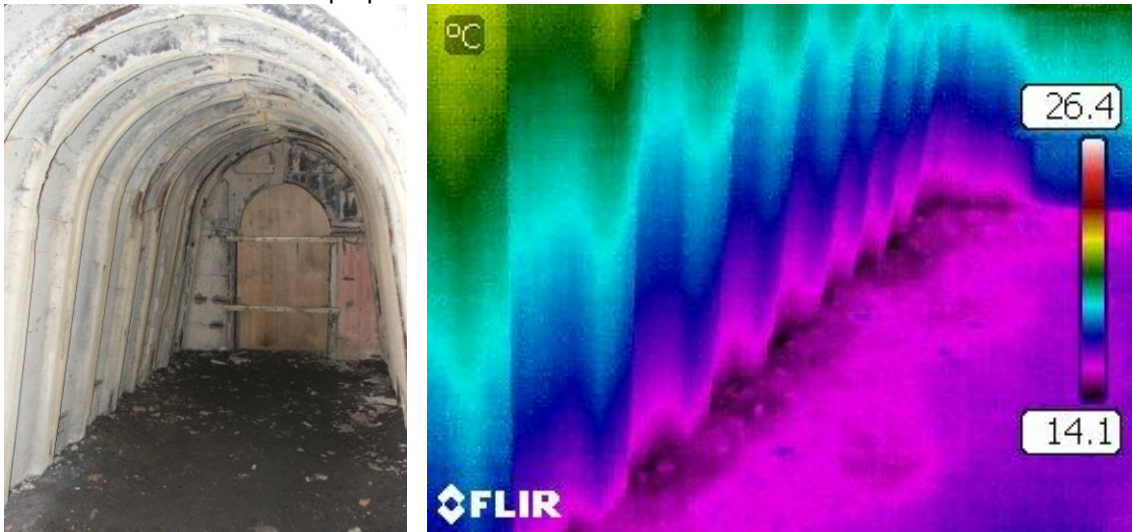
On a dry day the infrared thermography showed a colder zone around the base of the walls (Fig. 11.13), and while this was partly attributed to heat rising, due to the heater used to exaggerate temperature differences, it may also have been due to evaporative cooling. The electrical resistivity measurements were higher for a zone at the base of the walls, extending up to around 0.6 m, and so when considered together the two sets of readings appeared to indicate a zone of rising damp.

Fig. 11.13. Infrared thermograph, showing a cooler zone at the base of the walls (Maureen Young, Historic Scotland), with internal photograph for reference. The infrared thermograph is a false colour image showing the surface temperature of surfaces in °C, where the red areas are warmest and the purple areas are coolest

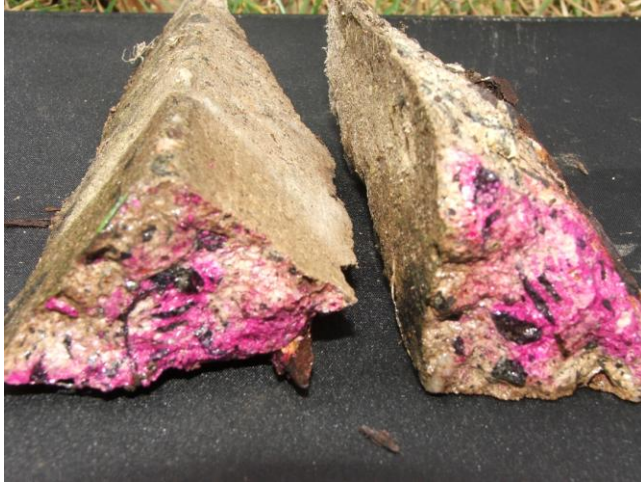
11.16). This suggested that the corrosion of the reinforcements had not occurred due to carbonation of the concrete.

Fig. 11.16. Staining of concrete from the NMOF shelter with phenolphthalein indicator. The pH of the purple areas is above 9, and these areas have therefore not carbonated.

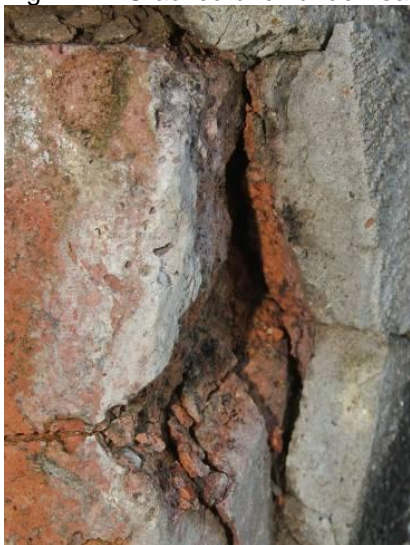
Fig. A1.1. Cracked brick underneath the delaminating render on Building 32

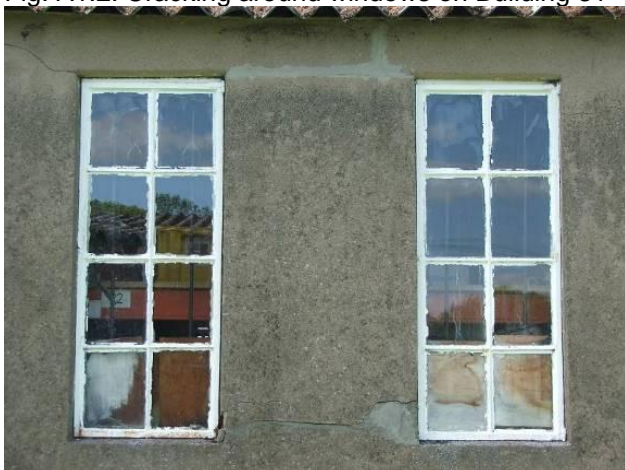
Fig. A1.2. Cracking around windows on Building 31

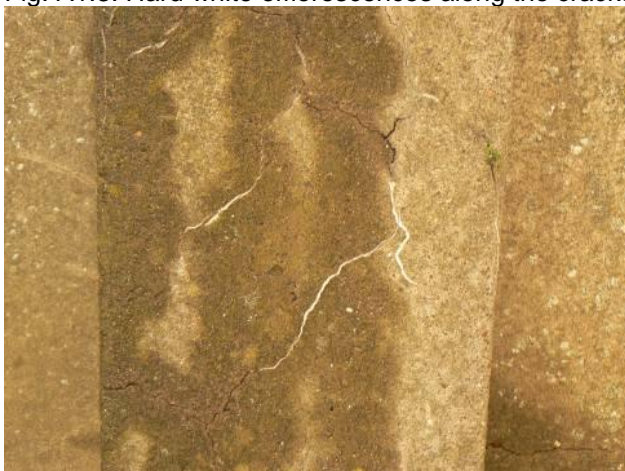
Fig. A1.3. Hard white efflorescences along the cracks on Building 38

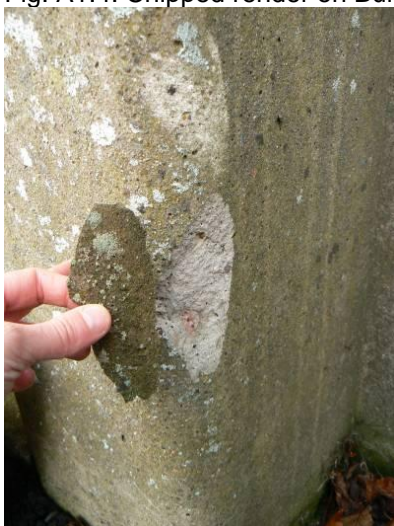
Fig. A1.4. Chipped render on Building 25

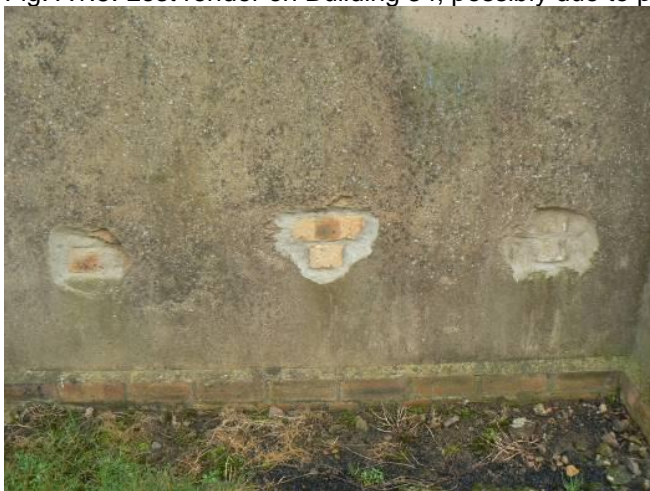
Fig. A1.5. Lost render on Building 34, possibly due to previous fixtures

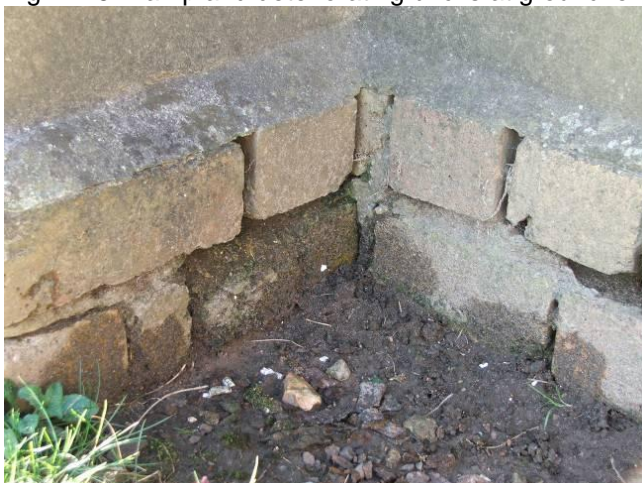
Fig. A1.6. Damp and deteriorating bricks at ground level with missing pointing on Building 31

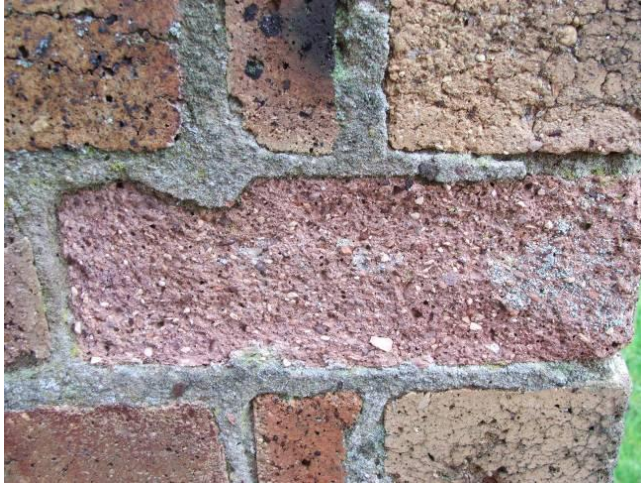
Fig. A1.7. Cracking and surface loss of bricks approximately 1.5 m from the ground on Building 42

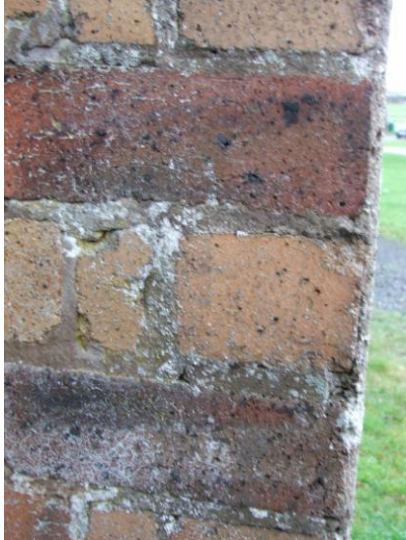
Fig. A1.8. Salt efflorescences on the bricks and mortar joints of an un-rendered external wall on Building 44

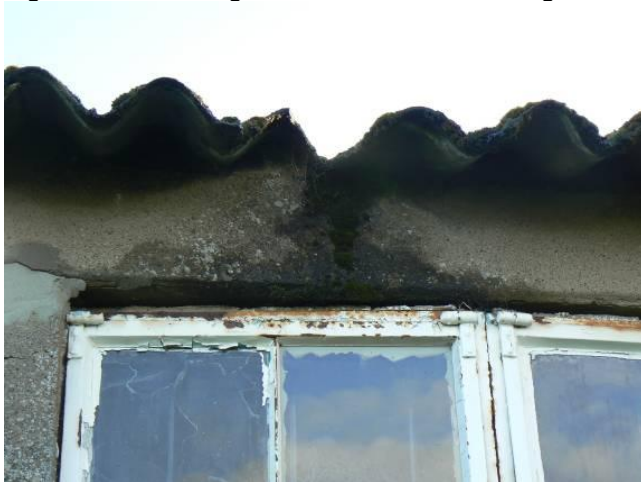
Fig. A1.9. Corroding window frame and damaged roof panelling on Building 32

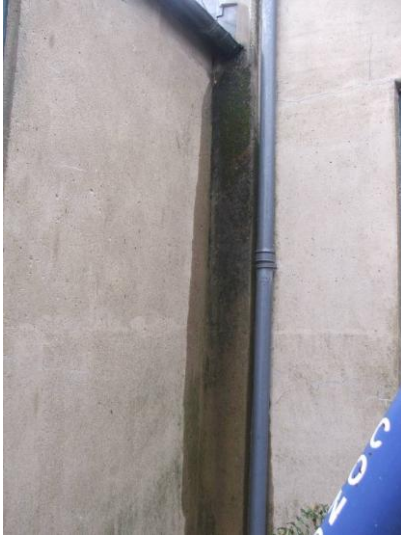
Fig. A1.10. Leaking gutter on Building 25

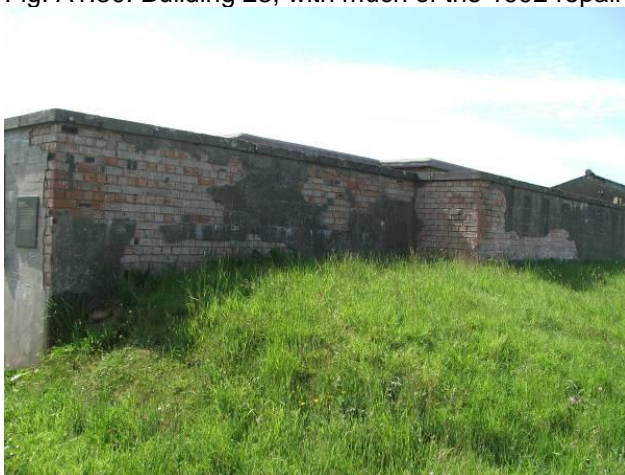
Fig. A1.30. Building 23, with much of the 1992 repair render lost (2010)

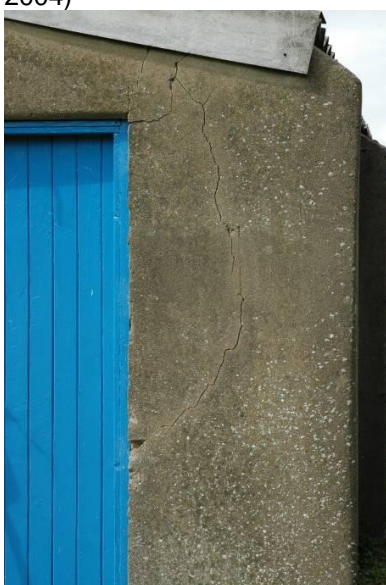
Fig. A1.31. Building 46, area of cracking adjacent to the door on the SE elevation (NMS 2004)

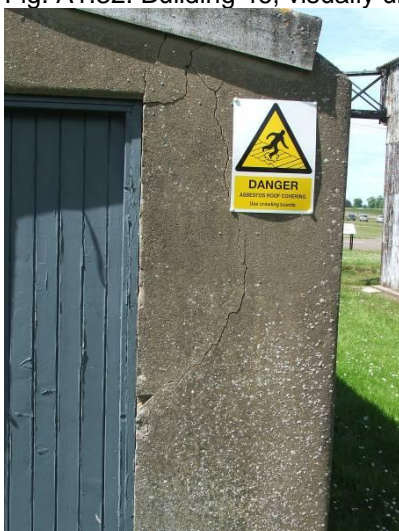
Fig. A1.32. Building 46, visually unchanged area of cracking (2010)

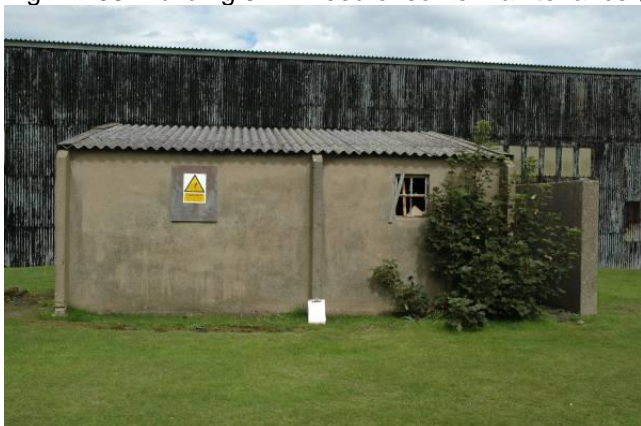
Fig. A1.33. Building 34 in need of some maintenance (NMS 2004)

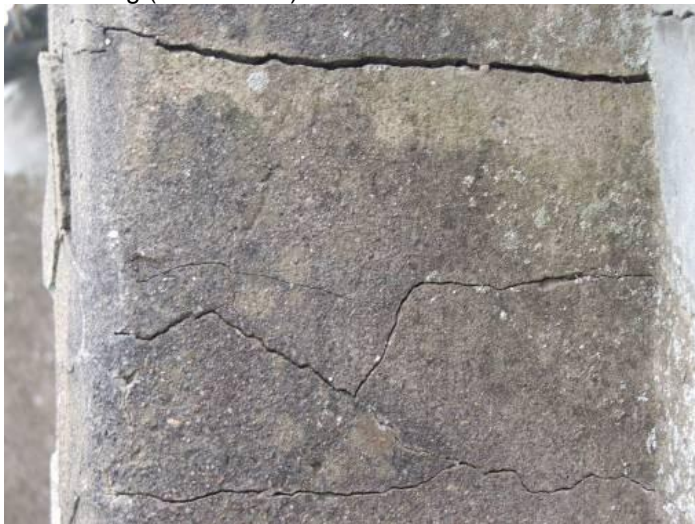
Fig. A1.39. Building 32, cracked render on the second pier from SW, on the NW elevation of the building (13/10/2010)

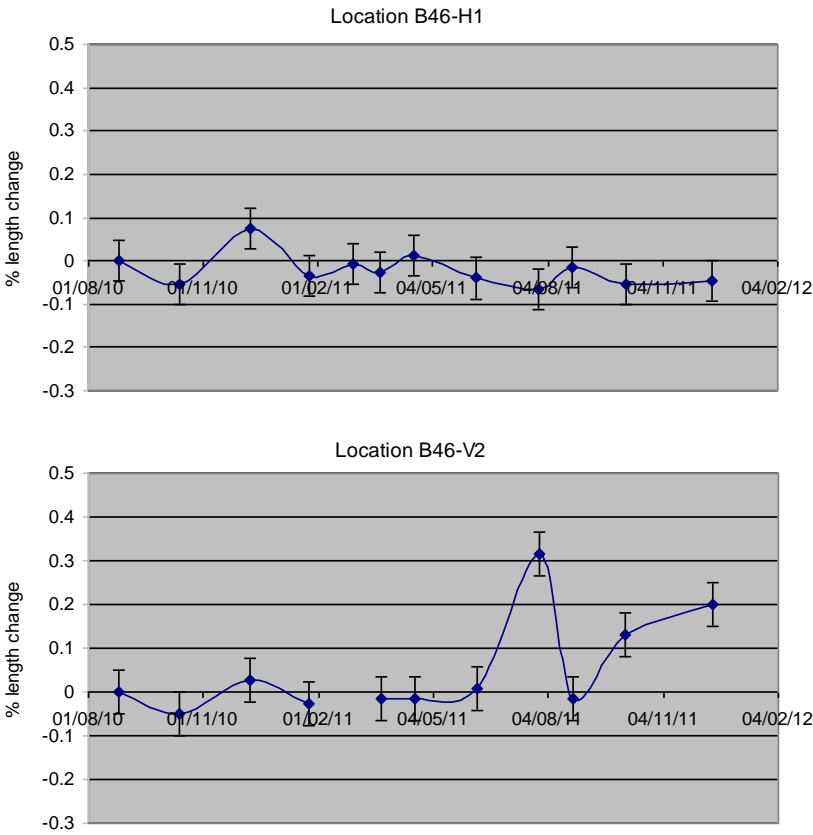
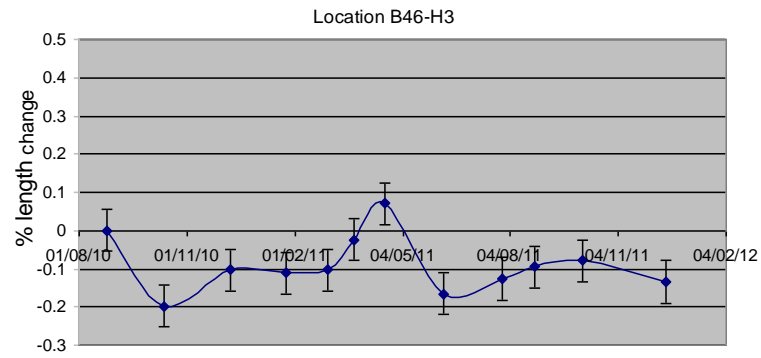
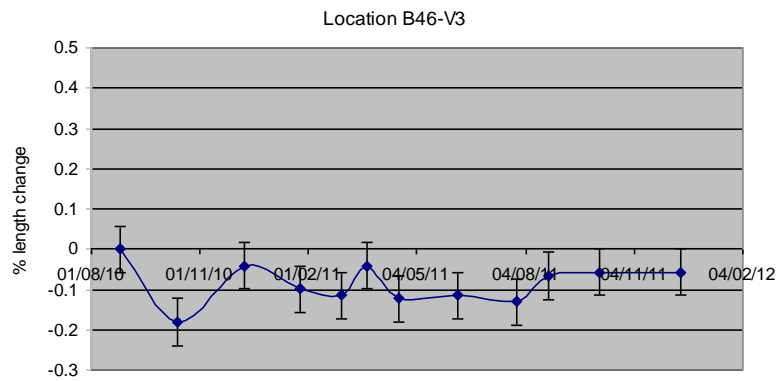
Figs. A1.42.-A1.45. Strain measurement across the un-cracked render on Building 46

A1.4.1 Monitoring of the un-cracked render on the SE and NW elevations of Building 46

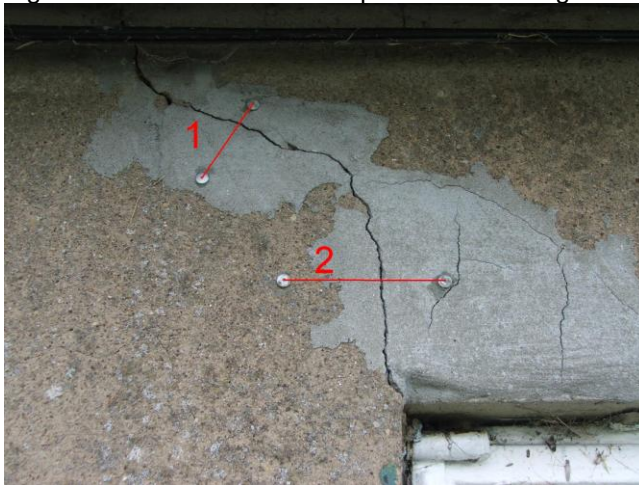
Fig. A1.46. Location of datum points on Building 26

A1.4.2 Strain measurement across the cracking above a window on the E elevation of Building 26

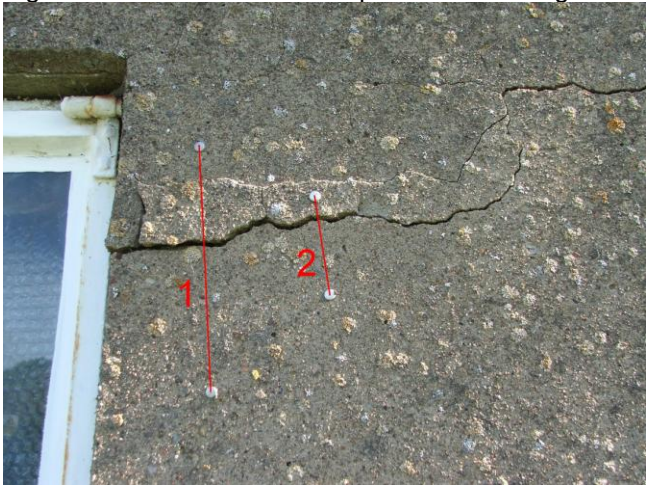
Fig. A1.49. Location of datum points on Building 31

A1.4.3 Strain measurement across the cracking above a window on the SW elevation of Building 31

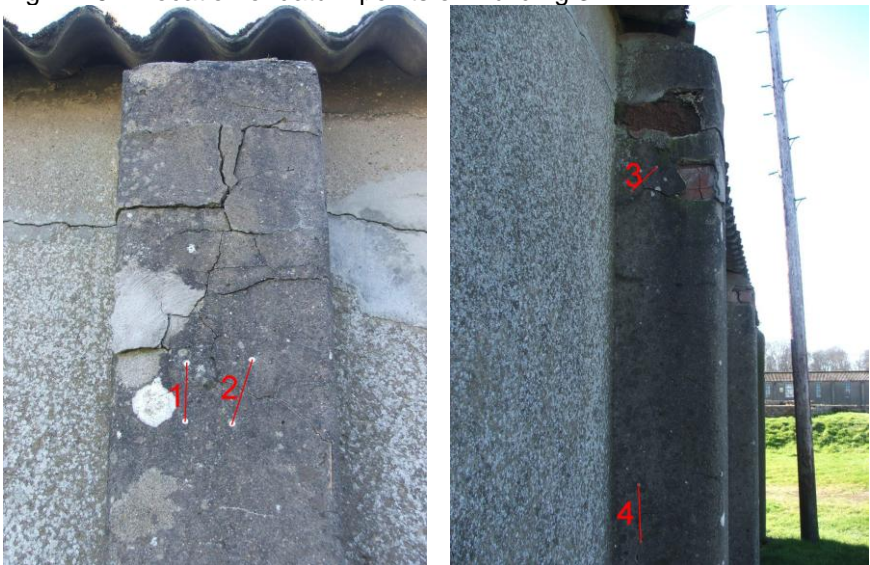
Fig. A1.51. Location of datum points on Building 32

A1.4.4 Strain measurement across the cracking on a pier on the NW elevation of Building 32

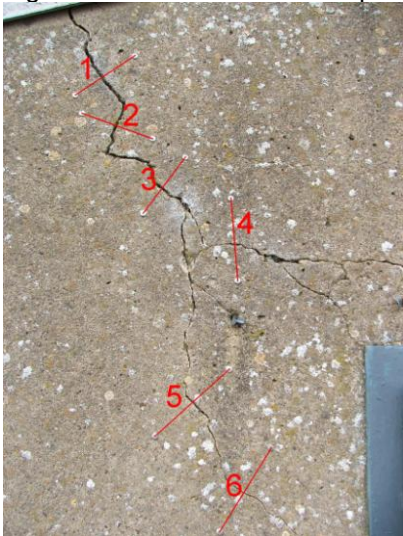
Fig. A1.54. Location of datum points on Building 42

A1.4.5 Strain measurement across the cracking above the door on the SE elevation of Building 42

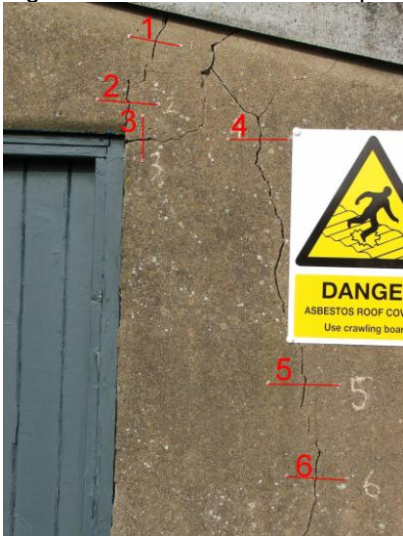
Fig. A1.57. Location of datum points on Building 46

A1.4.6 Strain measurement across the cracking beside the door on the SE elevation of Building 46

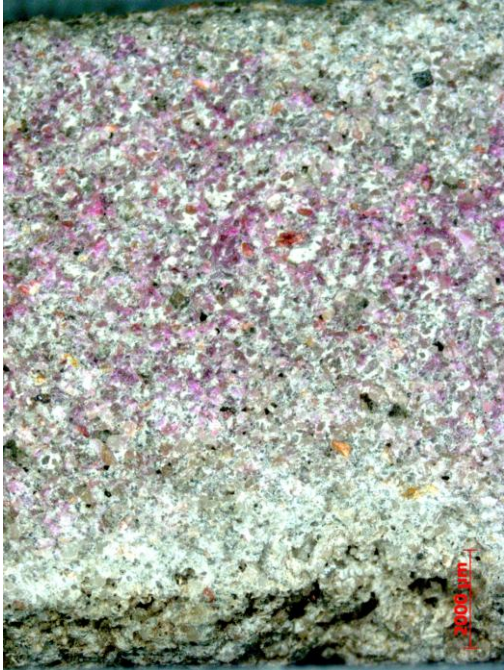
Slight staining of the middle of the section, suggesting that the surface and the interface with the bricks had carbonated, and that the middle section was carbonated in places.
B32 OR

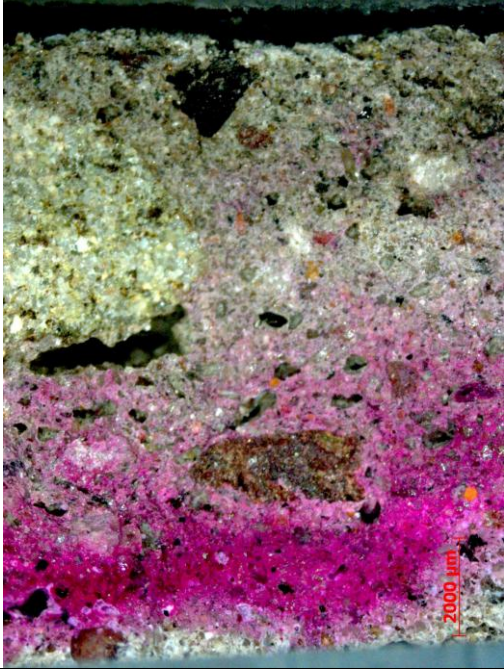
Deep staining towards the bottom of the section, suggesting that this zone was not carbonated, but that the surface and interface with the bricks had carbonated.
B47 OR		No staining, suggesting that the sample was at least partially and possibly fully carbonated.
B23 RR		No staining, suggesting that the sample was at least partially and possibly fully carbonated.

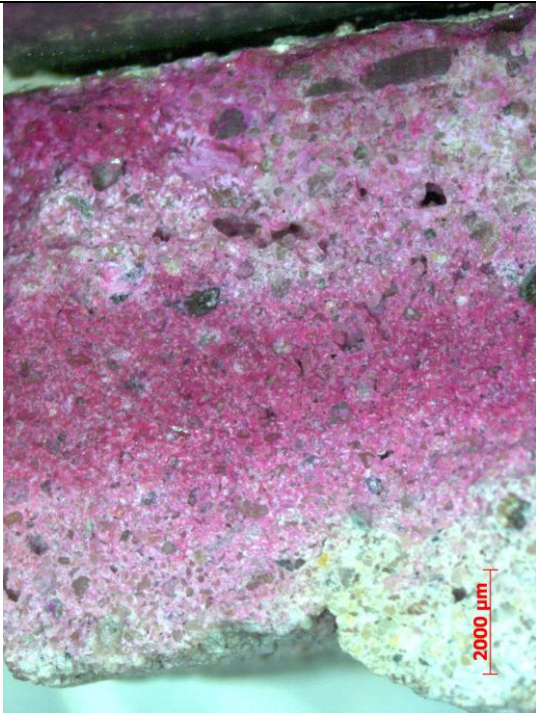
B25 RR

A micrograph of a concrete section labeled B25 RR. The image shows a cross-section of concrete with a dense, granular texture. There is a prominent horizontal band of deep pink/red staining across the middle of the sample. Above this band, the concrete is lighter in color. Below the band, there is a transition to a more yellowish-green color. A red scale bar in the bottom right corner indicates 2000 μm.	<p>Deep staining of the middle of the sample and the top 2 mm just below the surface, suggesting that these areas had not carbonated. The interface with the bricks had carbonated and the area around the voids approximately 3 mm below the surface had begun to carbonate.</p>
ARSC	<p data-bbox="667 860 1000 891">Surface of the concrete section</p>

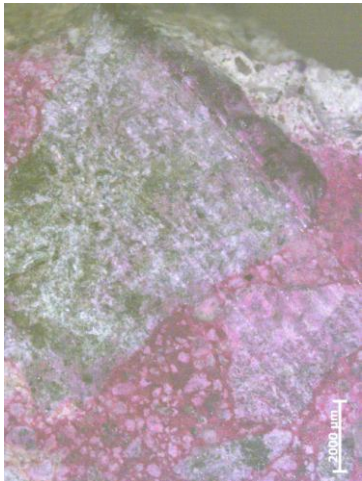
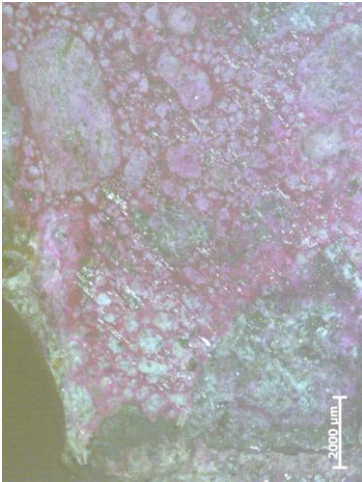
<p data-bbox="588 1874 1080 1935">Bottom of the concrete section, with traces of corroded steel on the lower left</p> Two micrographs of a concrete section labeled ARSC. The top micrograph shows the surface of the concrete section, with a pink/red staining pattern. The bottom micrograph shows the bottom of the concrete section, with a similar staining pattern and some darker, possibly corroded steel visible in the lower left corner. Both images have a 2000 μm scale bar in the bottom right corner.	<p>Deep staining through most of the sample, suggested that it had not carbonated. The surface and bottom of the sample were only partially stained and had probably begun to carbonate.</p>

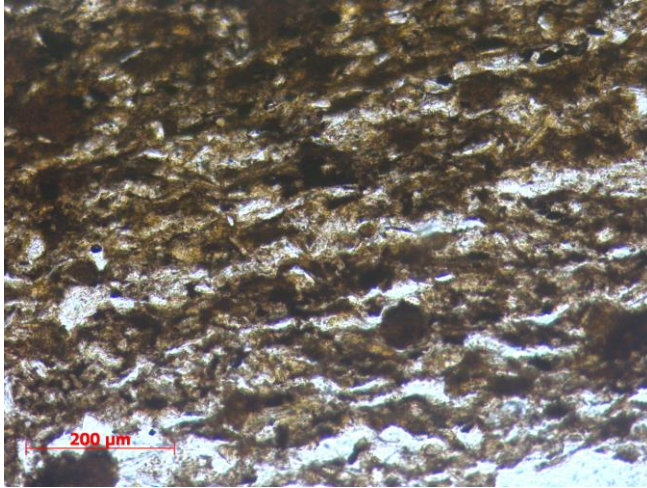
Fig. A2.20. Aggregate particle thought to be related to the blistering: mudstone fragment with prominent cleavage, plane polarized light, field of view: 875 μm across

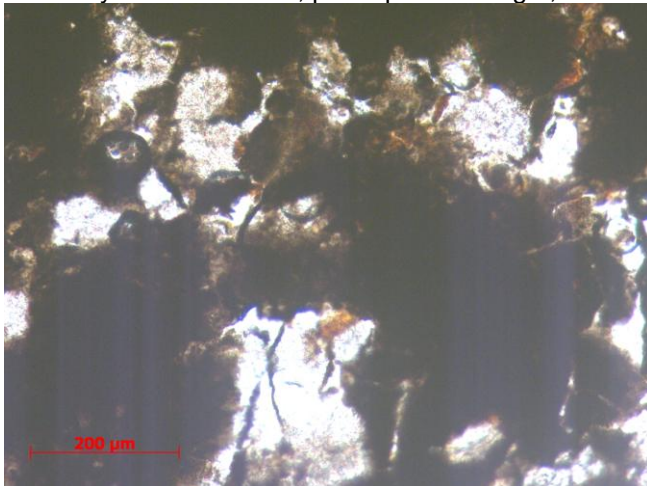
Fig. A2.21. Aggregate particle thought to be related to the blistering: a mud-rich particle with some crystalline material, plane polarized light, field of view: 875 μm across

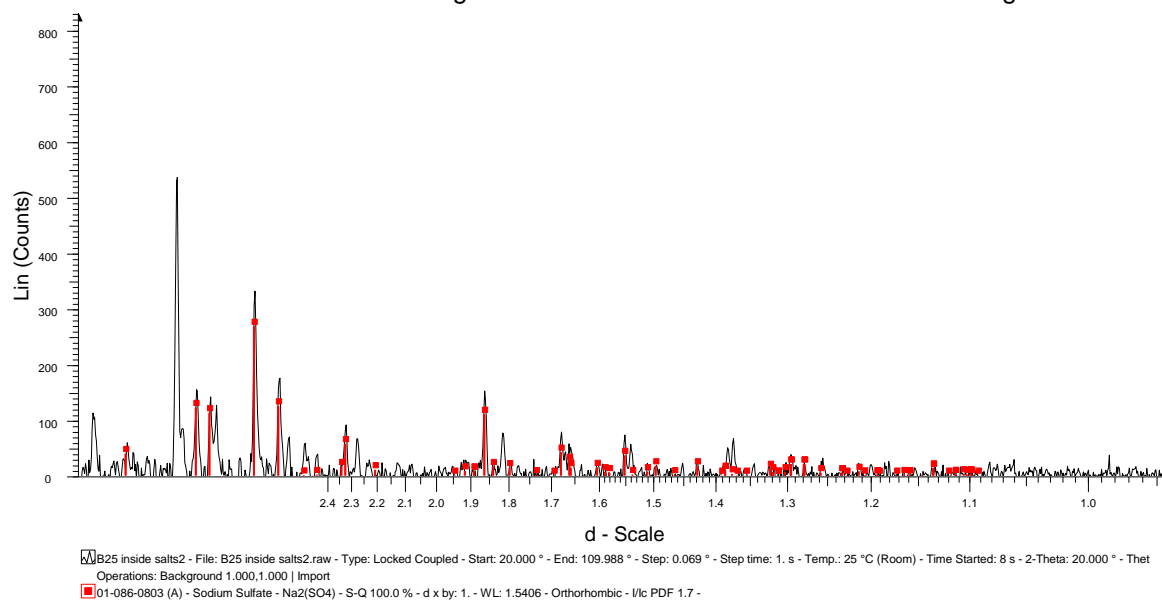
Fig. A3.2. Salt efflorescences from inside Building 25
